## **Pre-Purchase Standard Property & Timber Pest Report**

| Report number: | 2134 |
| Inspection Date: | 23rd Jun, 2025 |
| Property Address | Tingalpa QLD 4173, Australia |

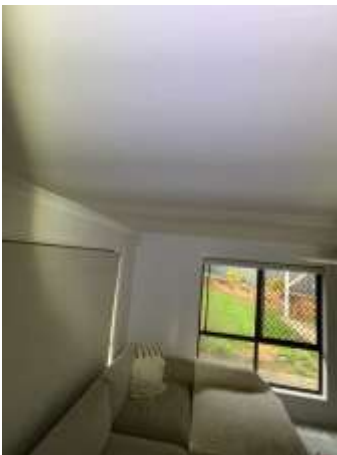
Sagging and Creasing visible on ceiling plasterboards, Recommend repair by engaging a licensed Plasterer.

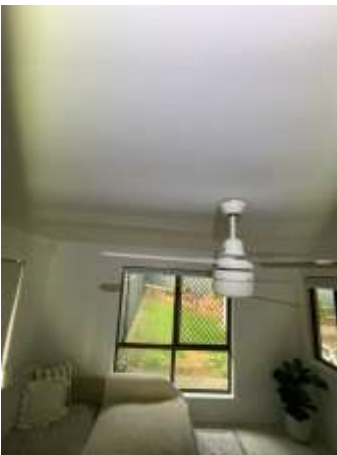
Sagging and Creasing visible on ceiling plasterboards, Recommend repair by engaging a licensed Plasterer.

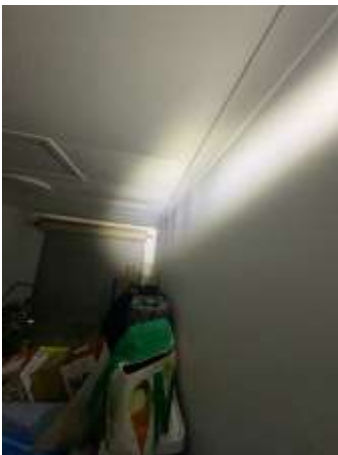
Sagging and Creasing visible on ceiling plasterboards, Recommend repair by engaging a licensed Plasterer.

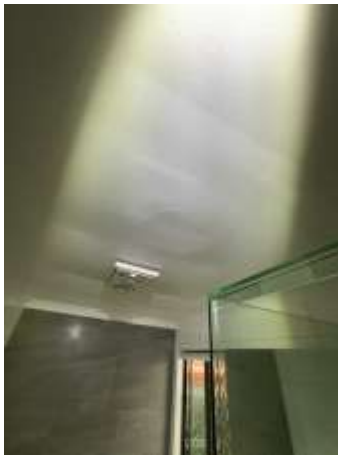
Sagging and Creasing visible on ceiling plasterboards, Recommend repair by engaging a licensed Plasterer.

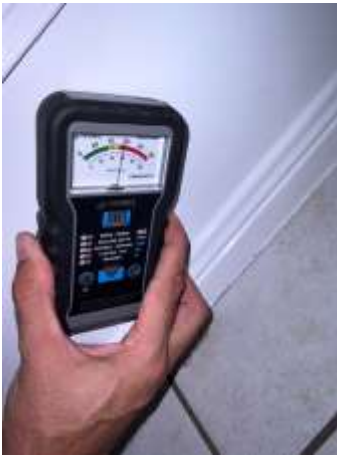
High moisture readings to internal walls. Invasive investigation recommended by a Licensed Builder to ascertain source of leak/moisture and to determine if there is any concealed damage to timber frames and other elements.

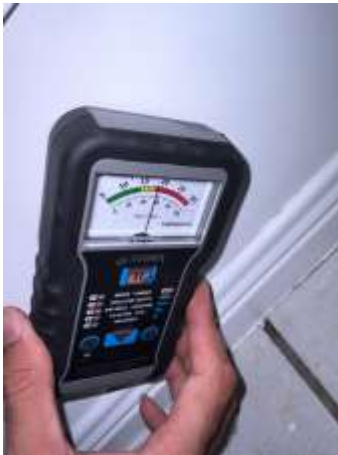
High moisture readings to internal walls. Invasive investigation recommended by a Licensed Builder to ascertain source of leak/moisture and to determine if there is any concealed damage to timber frames and other elements.

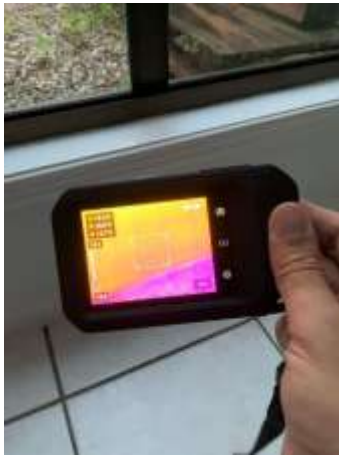
High moisture readings to internal walls. Invasive investigation recommended by a Licensed Builder to ascertain source of leak/moisture and to determine if there is any concealed damage to timber frames and other elements.

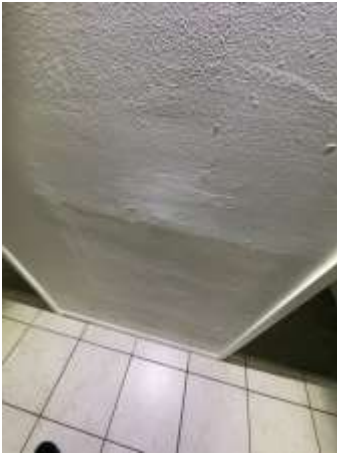
Bulge & patch marks on separate walls. Due to extent, engage a licensed Plasterer & Painter for repair proposals to improve aesthetic conditions.

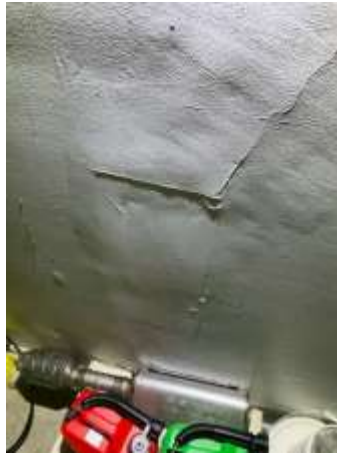
Bulge & patch marks on separate walls. Due to extent, engage a licensed Plasterer & Painter for repair proposals to improve aesthetic conditions.

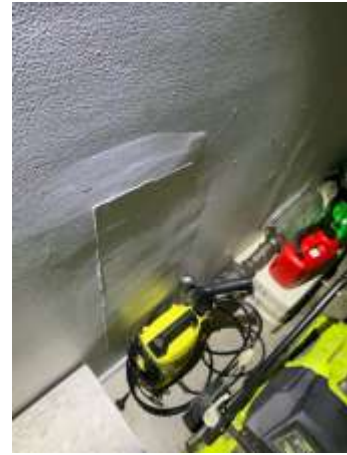
Bulge & patch marks on separate walls. Due to extent, engage a licensed Plasterer & Painter for repair proposals to improve aesthetic conditions.

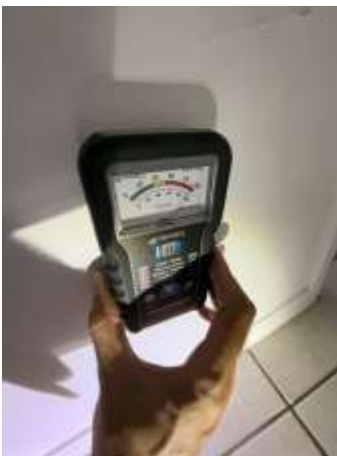
High moisture reading to walls adjacent to the Bathroom / Shower recess- Recommend engaging a Builder for further invasive investigation to ascertain cause and to determine if there is any concealed damage to the timber framing.

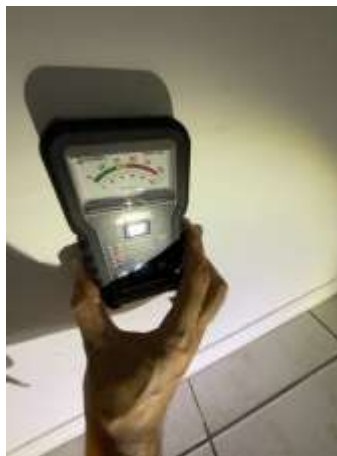
High moisture reading to walls adjacent to the Bathroom / Shower recess- Recommend engaging a Builder for further invasive investigation to ascertain cause and to determine if there is any concealed damage to the timber framing.

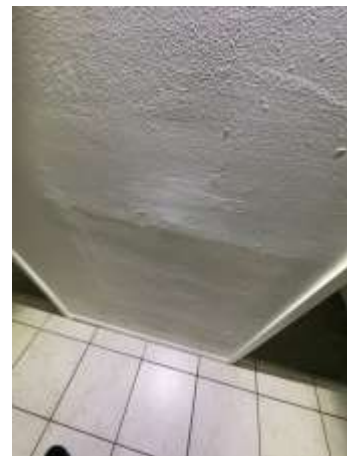
High moisture reading to walls adjacent to the Bathroom / Shower recess- Recommend engaging a Builder for further invasive investigation to ascertain cause and to determine if there is any concealed damage to the timber framing.

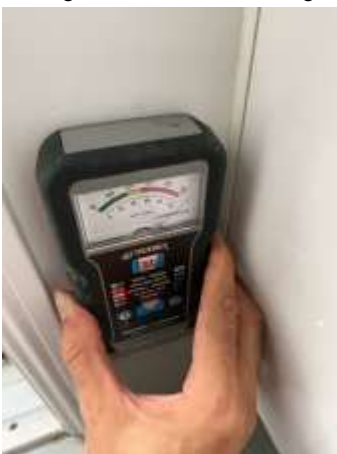
High moisture readings to internal walls. Invasive investigation recommended by a Licensed Builder to ascertain source of leak/moisture and to determine if there is any concealed damage to timber frames and other elements.

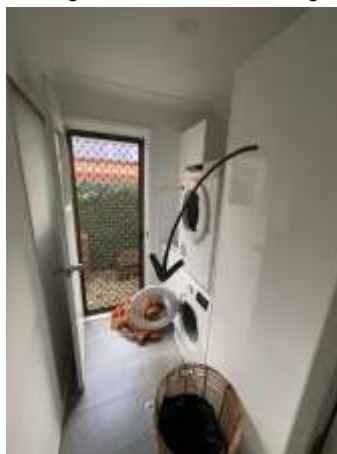
High moisture readings to internal walls. Invasive investigation recommended by a Licensed Builder to ascertain source of leak/moisture and to determine if there is any concealed damage to timber frames and other elements.

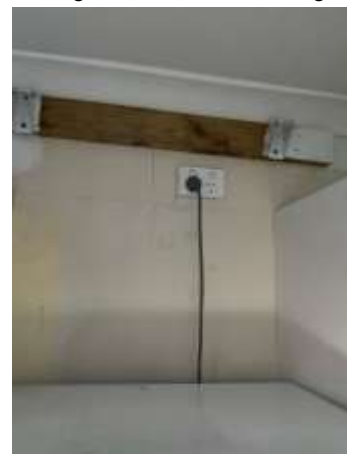
Poor wall and ceiling finishes are noted. Visible alterations and moist stain damages are noted. Recommend repairs by a licensed Plasterer and Painter.

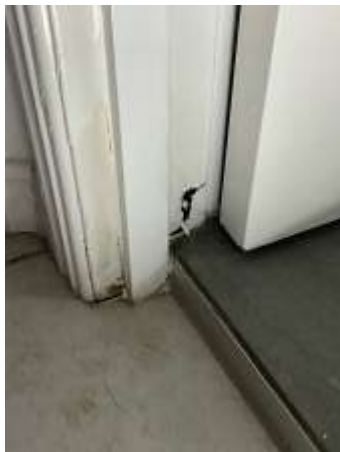
Wood rot and water damage to Door & window frames in seperate locations throughout the property. Engage a Licensed Builder for further advice and repair recommendations.

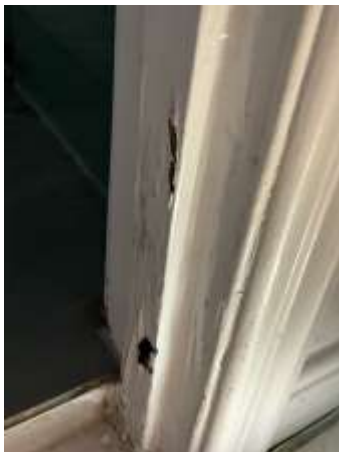
Wood rot and water damage to Door & window frames in seperate locations throughout the property. Engage a Licensed Builder for further advice and repair recommendations.

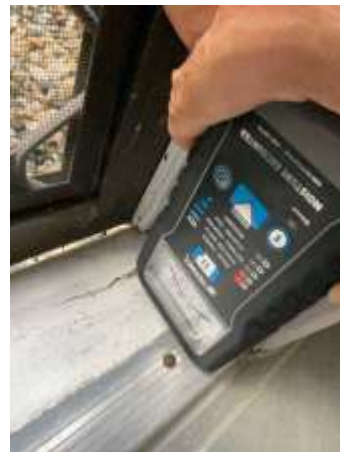
Wood rot and water damage to Door & window frames in seperate locations throughout the property. Engage a Licensed Builder for further advice and repair recommendations.

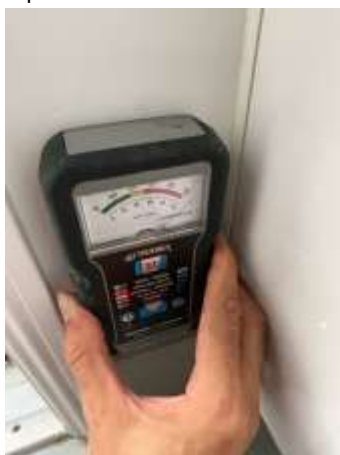
Wood rot and water damage to Door & window frames in seperate locations throughout the property. Engage a Licensed Builder for further advice and repair recommendations.

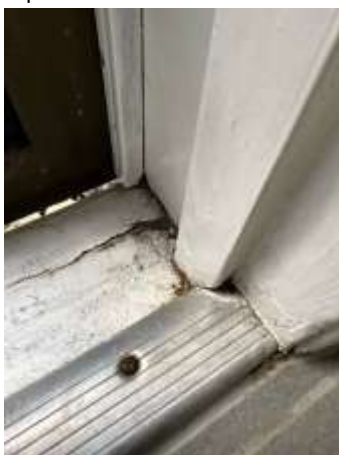
Wood rot and water damage to Door & window frames in seperate locations throughout the property. Engage a Licensed Builder for further advice and repair recommendations.

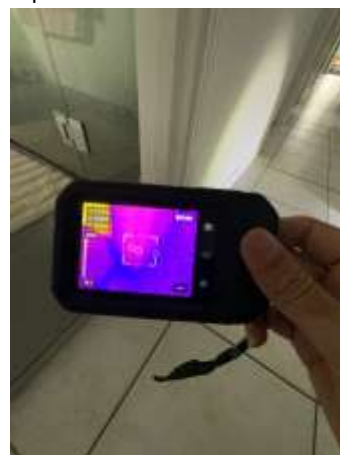
Wood rot and water damage to Door & window frames in seperate locations throughout the property. Engage a Licensed Builder for further advice and repair recommendations.

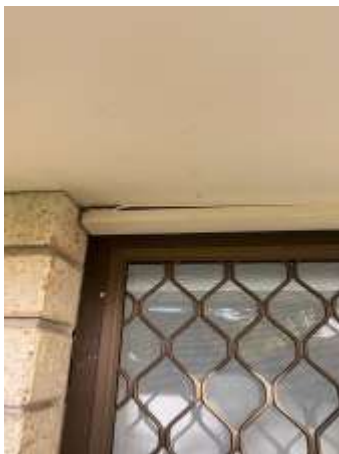
Sagging visible to the external soffit boards at the front elevation/ separation

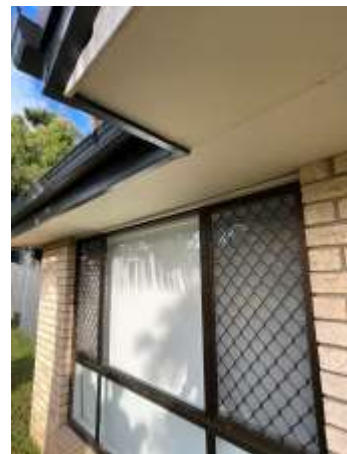
Sagging visible to the external soffit boards at the front elevation/ separation

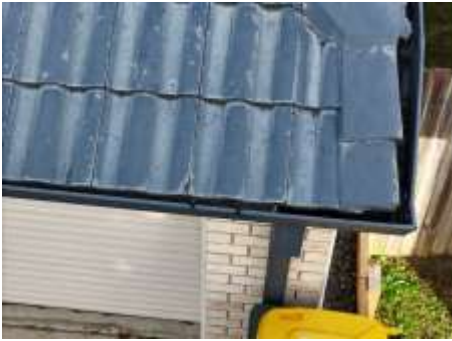
Cracked tiles and Missing/cracks to the pointing, recommend engaging a roofer to rectify and reduce the risk of water penetration into the building.

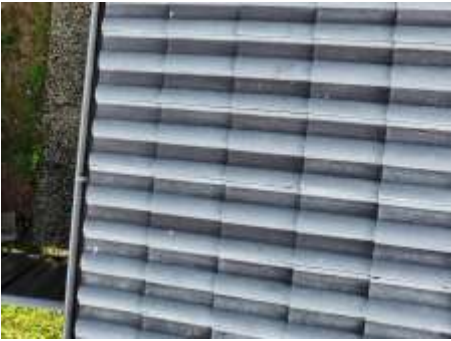
Cracked tiles and Missing/cracks to the pointing, recommend engaging a roofer to rectify and reduce the risk of water penetration into the building.

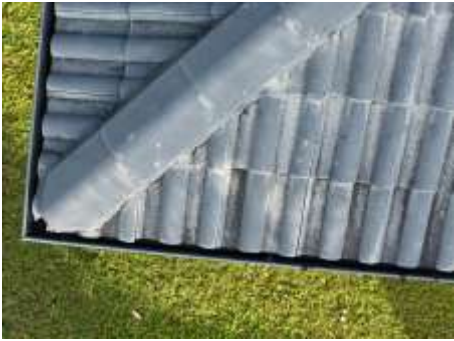
Cracked tiles and Missing/cracks to the pointing, recommend engaging a roofer to rectify and reduce the risk of water penetration into the building.

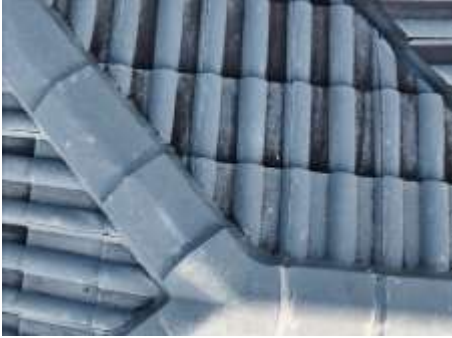
Cracked tiles and Missing/cracks to the pointing, recommend engaging a roofer to rectify and reduce the risk of water penetration into the building.

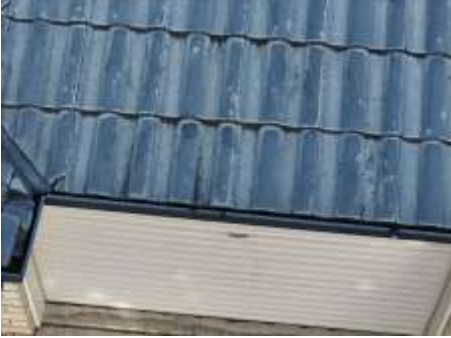
Cracked tiles and Missing/cracks to the pointing, recommend engaging a roofer to rectify and reduce the risk of water penetration into the building.

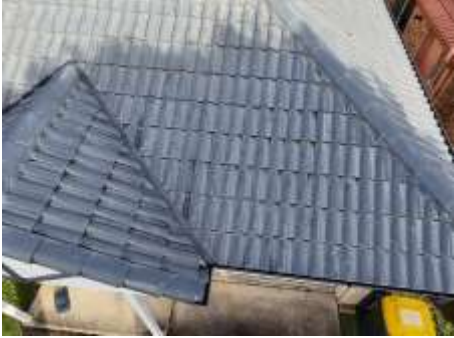
Cracked tiles and Missing/cracks to the pointing, recommend engaging a roofer to rectify and reduce the risk of water penetration into the building.

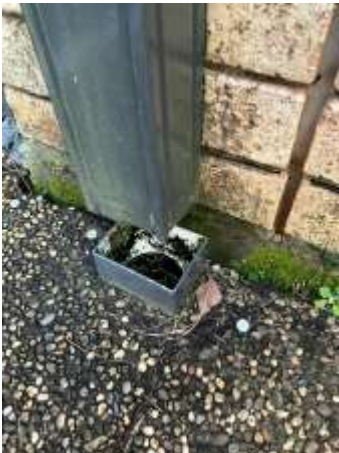
Few Downpipes damaged/cracked/dismounted or not properly connected to stormwater system- Recommend engaging a Plumber to repair & avoid the risk of foundation movement & other moisture related issues.

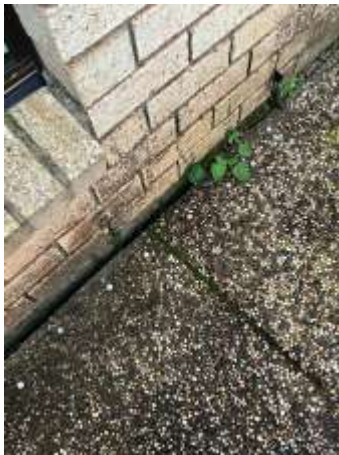
Side yard concrete slab been shifted, signs of subsidence and movement, inconsistent gap visible. Recommend engaging a licensed Builder for further assessment and repair proposals.

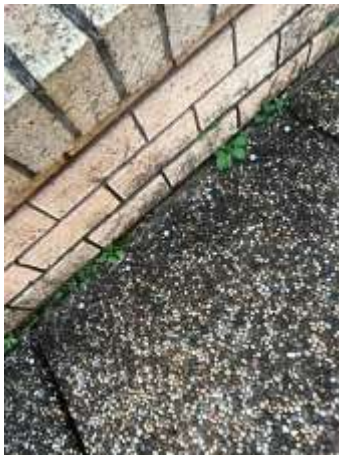
Side yard concrete slab been shifted, signs of subsidence and movement, inconsistent gap visible. Recommend engaging a licensed Builder for further assessment and repair proposals.

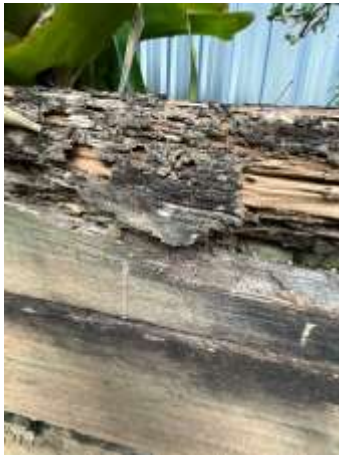
Termite workings and damage to the boundary fencing. Recommend replacement to affected ares and treatment to eradicate Termite colony.

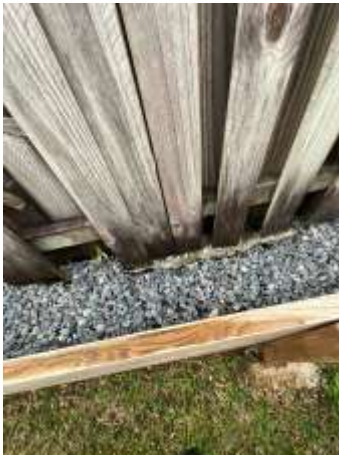
Leaning fences to parts - recommend engaging a Builder or Fencer to rectify to prevent further deterioration.

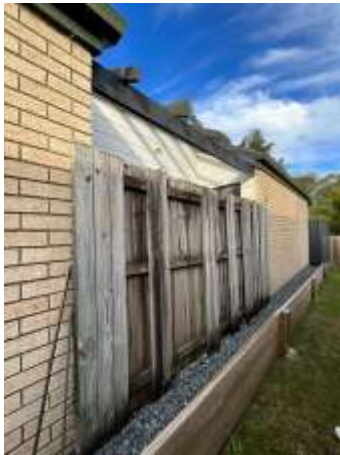
Leaning fences to parts - recommend engaging a Builder or Fencer to rectify to prevent further deterioration.

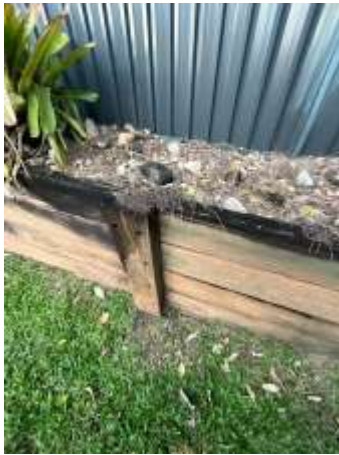
Wood rot/fungal decay to fence - to avoid further deterioration recommend engaging a fencing contractor to repair/replace

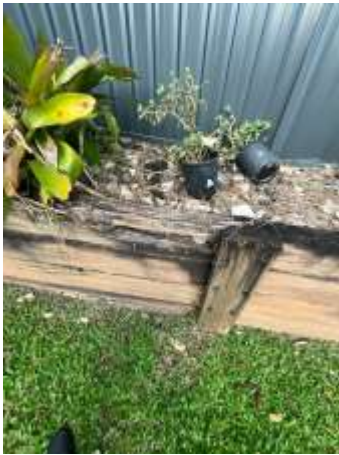
Wood rot/fungal decay to fence - to avoid further deterioration recommend engaging a fencing contractor to repair/replace

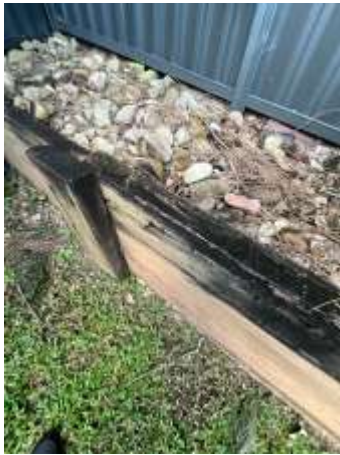
Wood rot/fungal decay to fence - to avoid further deterioration recommend engaging a fencing contractor to repair/replace

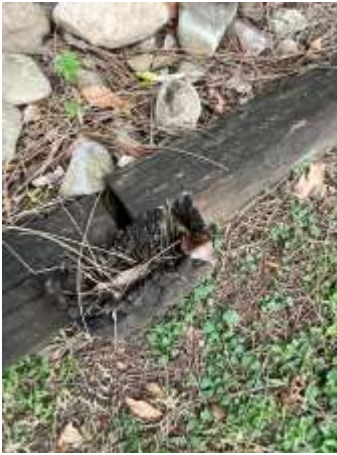
Wood rot/fungal decay to fence - to avoid further deterioration recommend engaging a fencing contractor to repair/replace

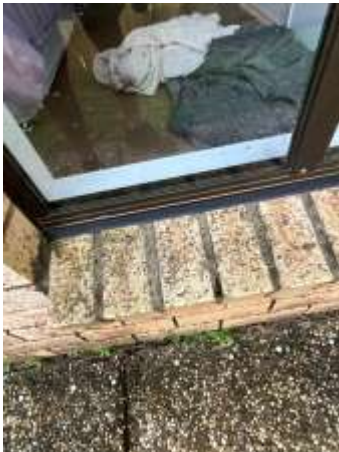
Mould cleaning recommended from the external bricks

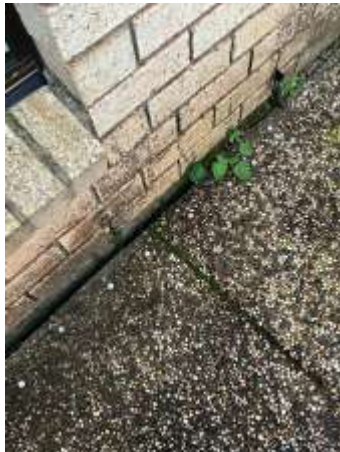
Mould cleaning recommended from the external bricks

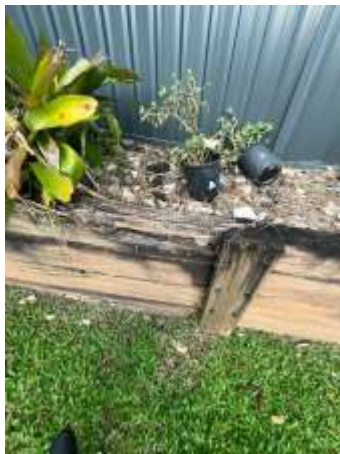
| Additional Comments | Termite workings to Retaining walls |

Termite activity

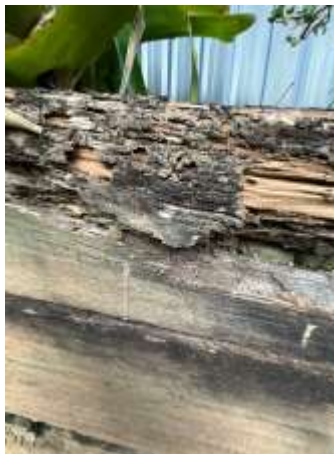
Termite activity

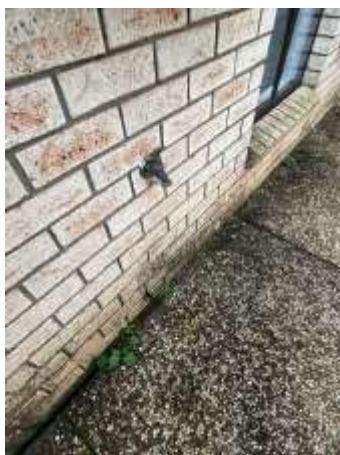
The presence of excessive moisture

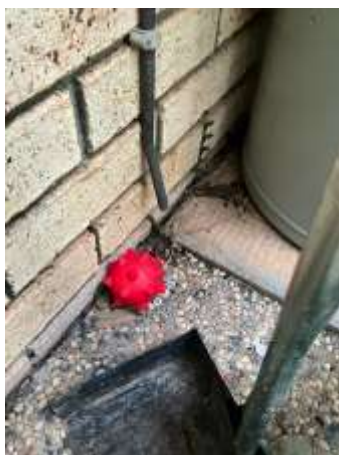
The presence of excessive moisture

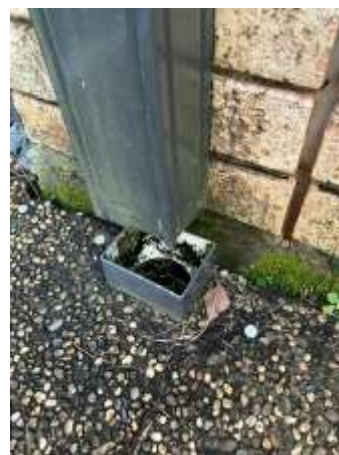
The presence of excessive moisture
