## **Pre-Purchase Standard Property & Timber Pest Report**

| Report number: | 2134 |
| Inspection Date: | 23rd Jun, 2025 |
| Property Address | Tingalpa QLD 4173, Australia |

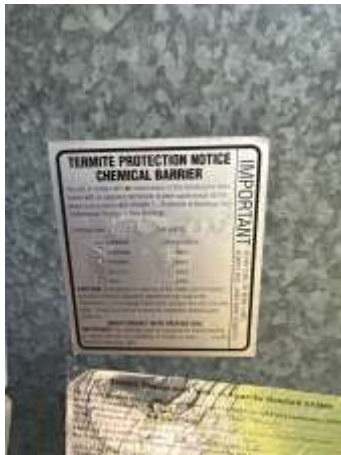
The previous termite management system stickers - please contact the installer
