## **Pre-Purchase Standard Property & Timber Pest Report**

| Report number: | 2134 |
| Inspection Date: | 23rd Jun, 2025 |
| Property Address | Tingalpa QLD 4173, Australia |

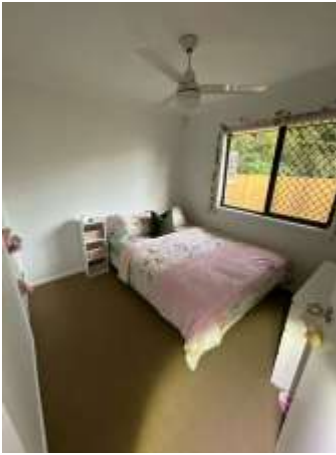
Showing examples of obstructions

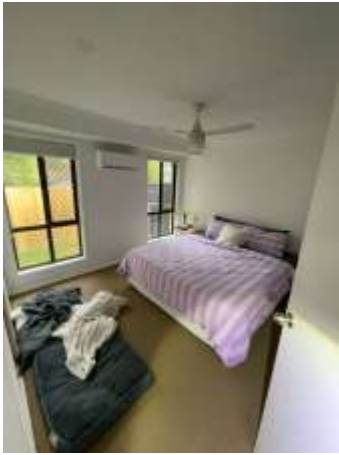
Showing examples of obstructions

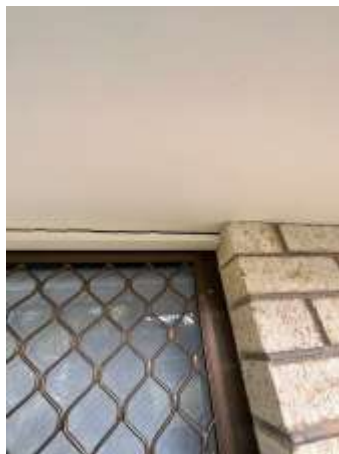
Sagging visible to the external soffit boards at the front elevation/ separation

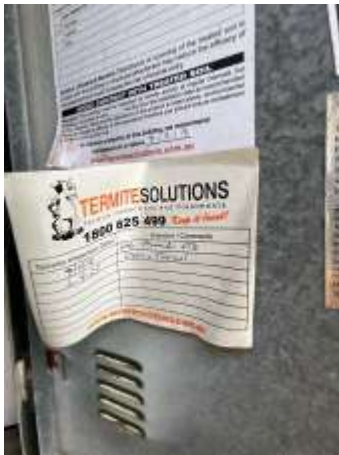
The previous termite management system stickers - please contact the installer

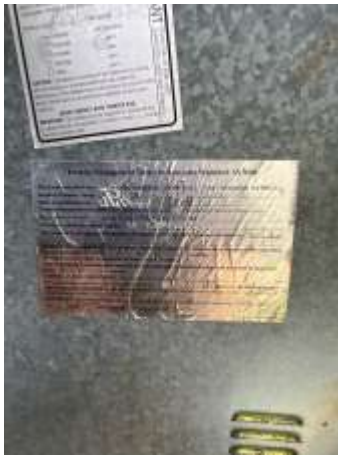
The previous termite management system stickers - please contact the installer

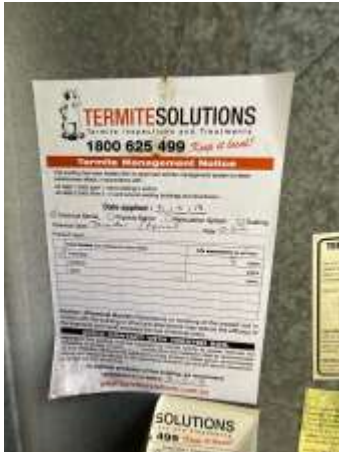
The previous termite management system stickers - please contact the installer
